**Cost Reductions
and
Product Consistency
Improvements
Using Unannealed
High- Frequency/Solid State
(UHFSS) Welded 409 Stainless
Steel Heat Exchanger Tubing**

**Edward D. Basta, Senior Metallurgical Engineer
Atlas Steel Products Co.
7990 Bavaria Road
Twinsburg, OH 44087
USA**

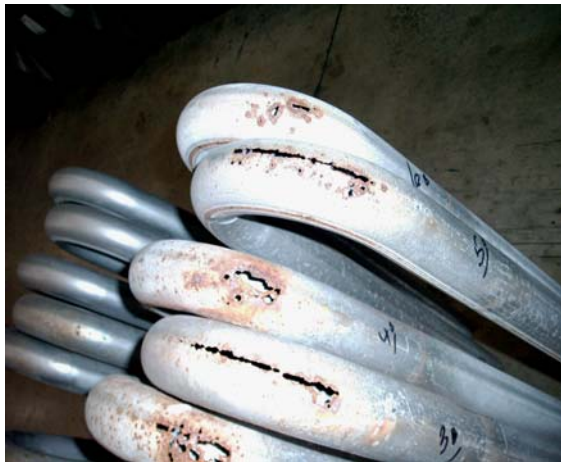
Figure 2: Corroded Aluminized Steel Heat Exchanger

Figure 2 shows a view of a commercial rooftop heat exchanger unit that had been replaced after only six years of service. The severe surface oxidation is evident on the weld seams and in other areas that have suffered coating diffusion due to heating above the diffusion temperature. The coating diffusion is evidenced by the lighter/whitish aluminum oxidation and a darker gray surface coloring.

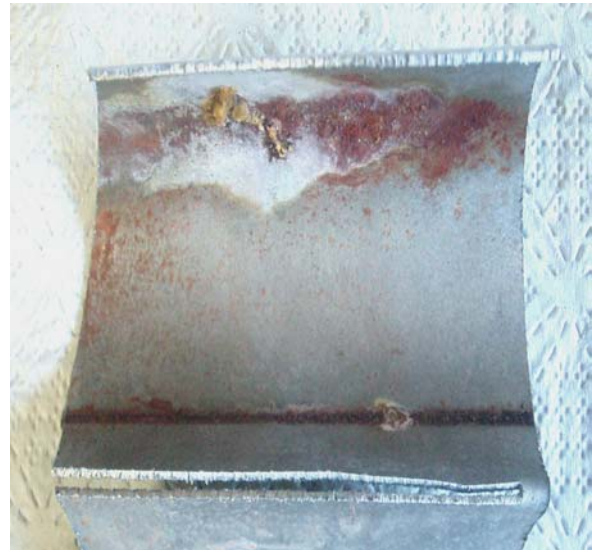
Figure 3: Oxidized Aluminized Steel Tube I.D. Section

Figure 3 shows an I.D. view of a section of this aluminized steel heat exchanger tube section that was cut from the heat exchanger unit. A heavy layer of corrosion is visible on the inside surface. The tube's I.D. weld seam is noted below the corroded area.

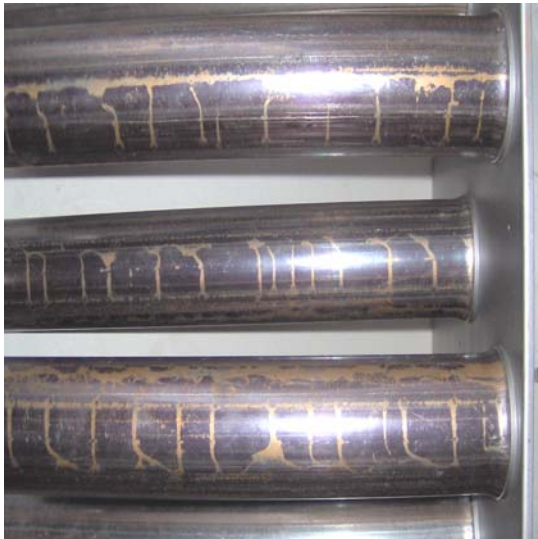
Figure 7: Dark and Streaky Surfaces of Laser Welded and Annealed Tubing

One disadvantage of the post-weld annealing/stress relieving process for laser welded 409 stainless steel heat exchanger tubing is the significant and varying surface discoloration that the heat treatment step causes. Since the tube is typically heated in the open air, not in an atmosphere-controlled furnace, the surface of the laser welded 409 stainless steel tubing usually develops a darker surface oxide hue ranging from a medium copper color to a very dark brown color, often with lighter streaks usually caused by dripping tube mill coolant. Figures 7 and 8 show views of these discoloration conditions.

While it may seem trivial that a tubular heat exchanger component that may be enclosed inside the HVAC cabinetry is discolored, the weld seam becomes very difficult if not impossible to locate while fabricating the tubing. In those cases where the tube seam is required to be specifically aligned relative to the tube bends, this may well be an important issue.

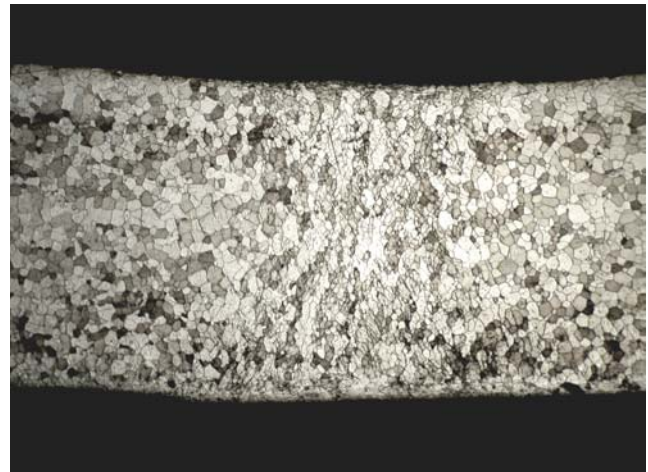
Figure 10: Typical UHFSS 409 SS Tube Weld Zone/HAZ

The UHFSS tube weld is vastly different than either TIG welding or laser welding in the 409 stainless steel material. As seen in Figure 10, the weld zone and HAZ is almost indistinguishable from the base material of the tube wall. This maintenance of a generally fine-grained equiaxed microstructure in the ferritic stainless alloy means that the resulting weld will be stronger and less prone to fatigue failure. The need for a post-welding anneal or stress relieve has been virtually eliminated due to this resulting uniformity in the weld zone.

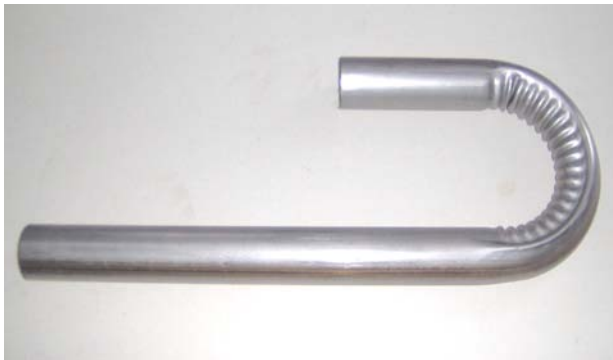
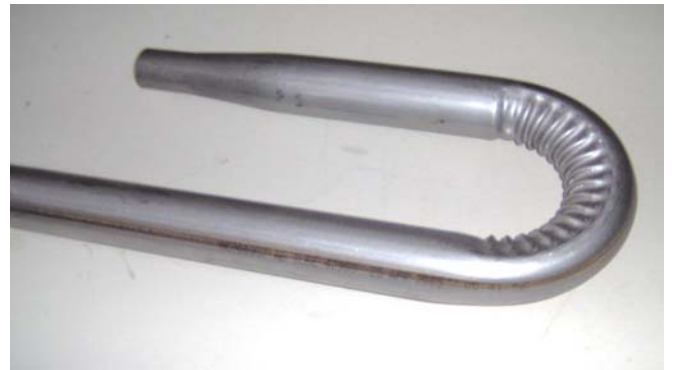
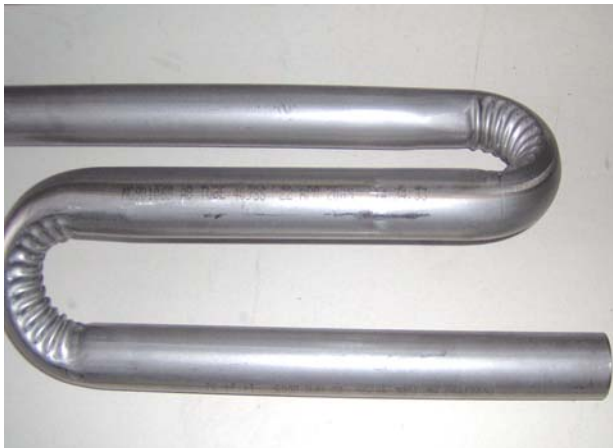
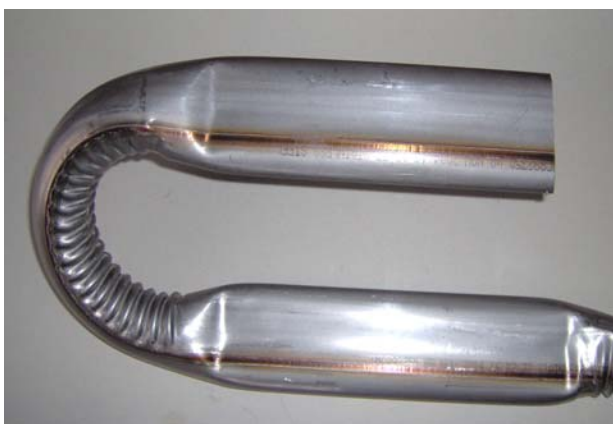
Figure 12: Wrinkle-bent "U-bend" tube

Figure 15: Wrinkle-bent and "pointed" U-bend tube

Figure 13: Serpentine Wrinkle-bent tube

Figure 14: Wrinkle-bent and flattened tube

This is due to fewer setup changes and/or mid-shift adjustments being required to the bender when a new lot of tube is loaded in the machine. It is not uncommon for a tube bender to need significant adjustments each time a new load of annealed tubing is started. Tests have shown that the properties of the as-welded 409 stainless tubing are much more consistent than those of multiple annealing lots, even when made from the same heat of raw material. Figures 12 through 15 show just a few of the many difficult bending configurations where UHFSS welded 409 stainless steel heat exchanger tubing has been successfully used.
